Intel[®] 82801EB I/O Controller Hub 5 (ICH5) / Intel[®] 82801ER I/O Controller Hub 5 R (ICH5R)

Specification Update

November 2007

Document Number: 252517-028

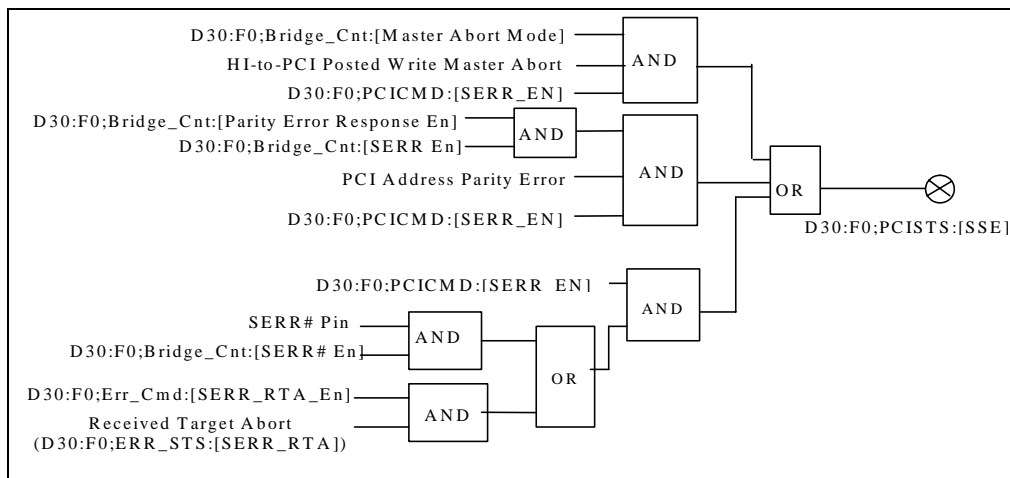
Figure 5.

The Figures 5-7 are inaccurate and is being replaced with the following figures:
