# Intel<sup>®</sup> 82801CA I/O Controller Hub3 (ICH3-S)

Specification Update

*September 2006*

Order Number: 290739-014

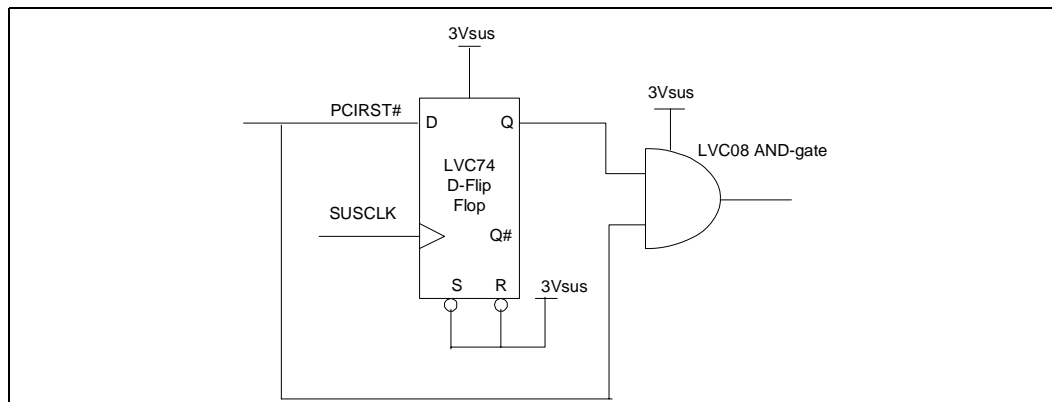
**Problem:** The ICH3 specified 1–3 RTC timing of SUS\_STAT# inactive to PCIRST# inactive violates the LPC specification of “at least 60  $\mu$ s.”

**Implication:** Some LPC devices may not properly reset resulting in failure of the system to boot or resume from a sleep state.

**Workaround:** Use any one of these three workarounds:

1. Delay PCIRST# by 1 SUSCLK using a D-flop and an AND gate to the LPC devices.
