Intel[®] I/O Controller Hub 6 (ICH6) Family

Specification Update

October 2009

Order Number: 301474-027

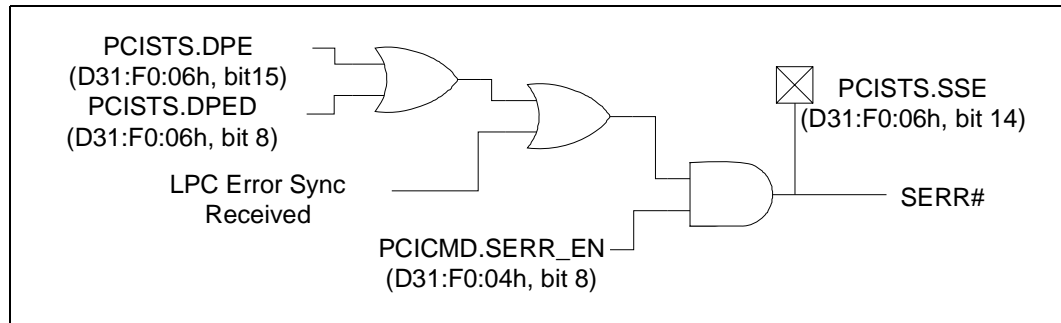
Figure 1. LPC Bridge SERR# Generation

Several internal and external sources of the LPC Bridge can cause SERR#, as described below.

The first class of errors is parity errors related to the backbone. The LPC Bridge captures generic data parity errors (errors it finds on the backbone) as well as errors returned on the backbone cycles where the bridge was the master and parity error response is enabled. If either of these two conditions is met, and with SERR# enable (PCICMD.SERR_EN) set, SERR# will be captured.

Additionally, if the LPC Bridge receives an error SYNC on LPC bus, an SERR# will also be generated.
